Initial Analyses of Eagle River Flats Hydrology and Sedimentology, Fort Richardson, Alaska

Daniel E. Lawson, Susan R. Bigl, John H. Bodette and
Patricia Weyrick

March 1995

Cold Regions Research &
Engineering Laboratory

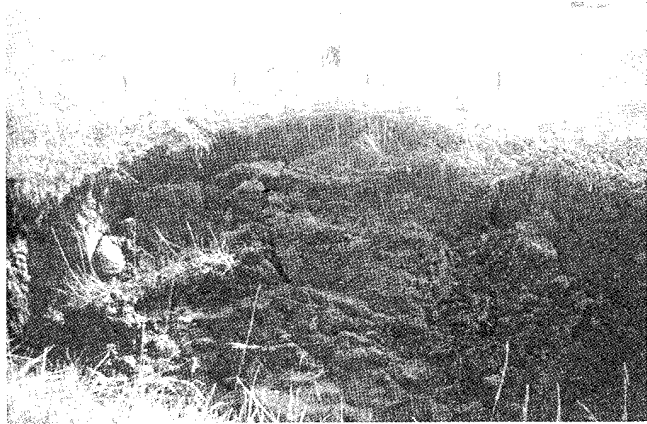
Figure 9. Headwall erosion study site. The line of stakes approximately parallels the gully crest. The hub stake is to the right of center behind the stake line.

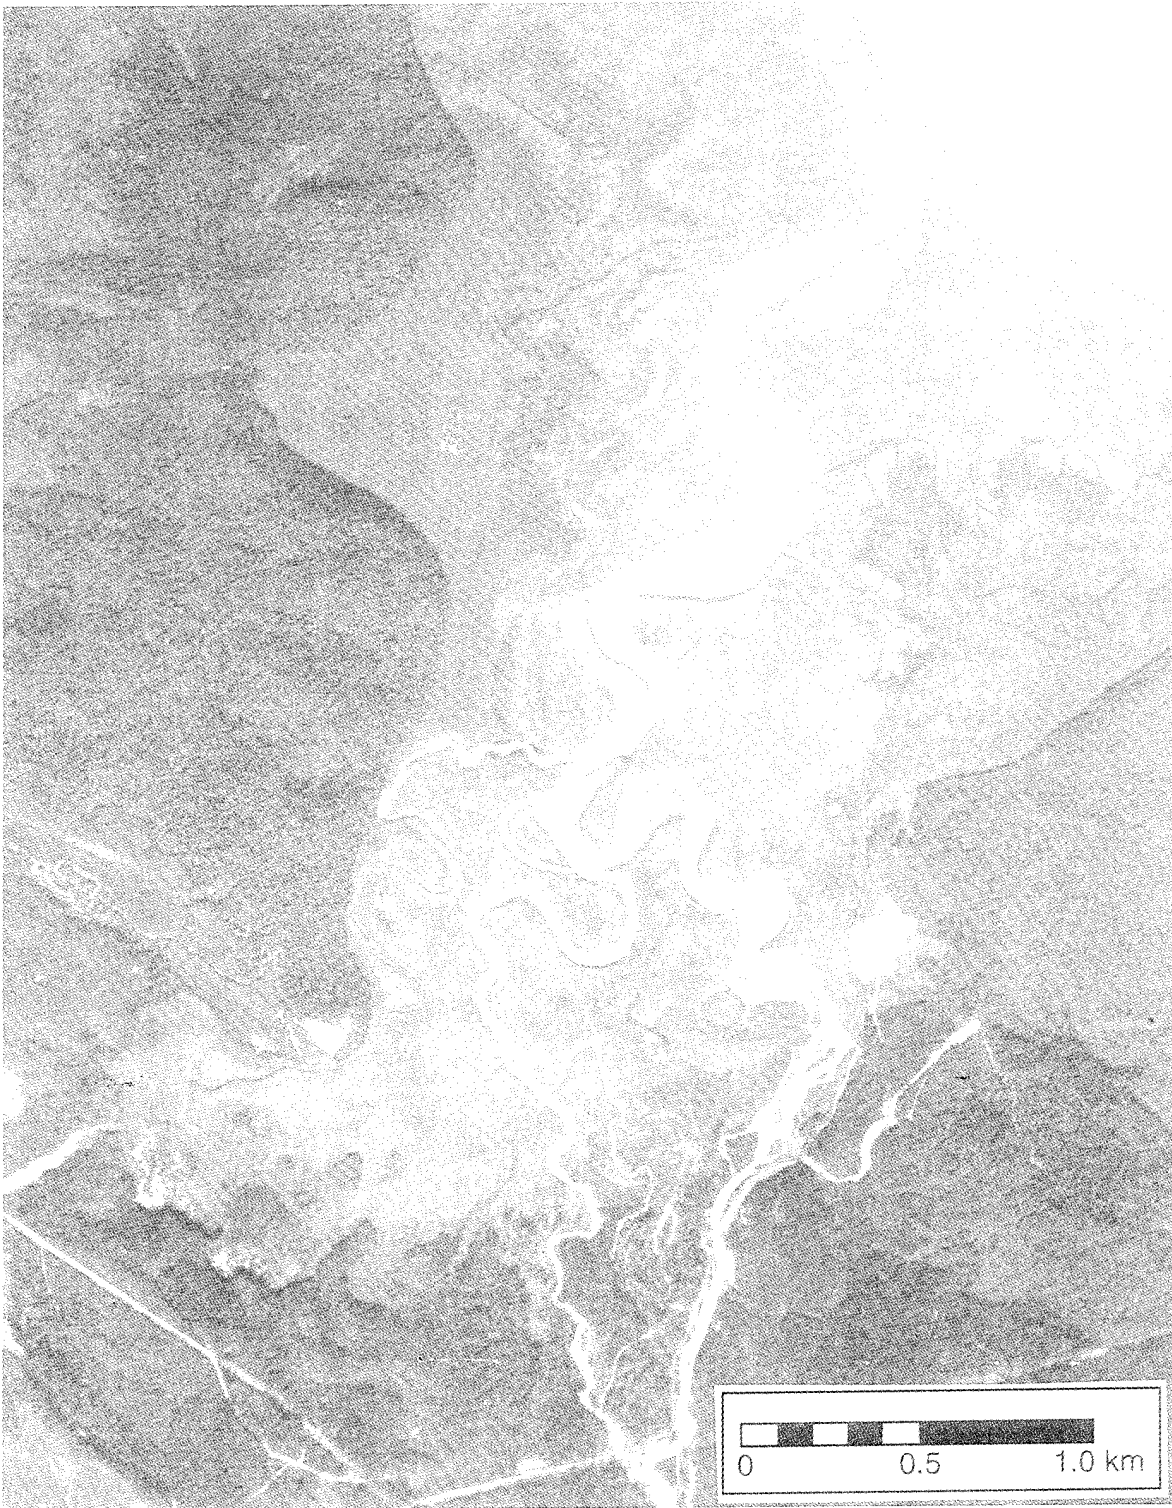
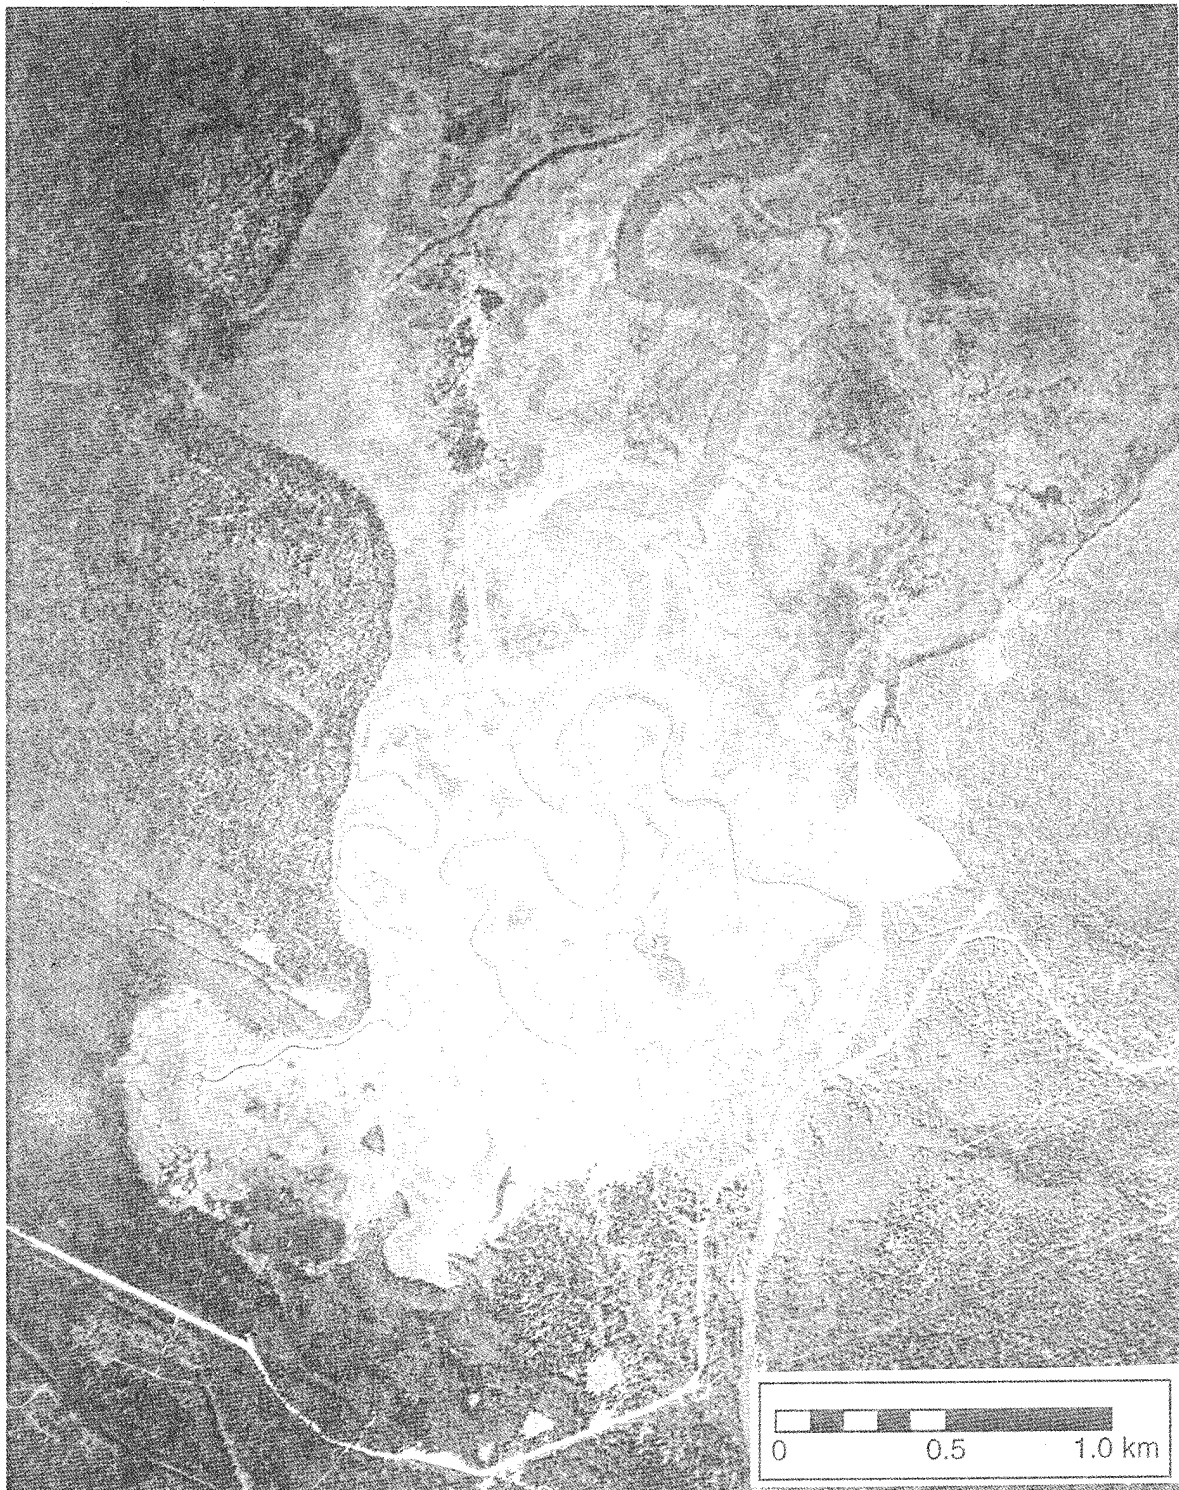
Figure 13. Aerial photographs of ERF.

a. 1950.

b. 1967.

c. 1993.

Aerial photographs from 1950, 1967 and 1993 reveal that the primary river channel (of three) was abandoned sometime between 1950 and 1967 (Fig. 13). By 1967, two channels diverged from Eagle River north of the Route Bravo bridge, the primary avenue of discharge now appearing to be the eastern course. Our initial review of these photographs does not reveal the cause of this change; however, it is clearly important to understanding the hydrology and sedimentology of the Flats.

Gullies have also progressively lengthened and deepened during the last 40 years, in some cases extending over an estimated 200 to 300 m. A significant extension of gullies toward the ponds and marshes is particularly evident on photographs covering the period of 1967–1993 (Fig. 13b and c), but the amount of recession cannot yet be quantified. Recession is in response to erosion during ebb flow from the ponds and mudflats into the gullies (Table 2). Erosion measurements in 1992 indicated that this recession is continuing at variable rates of up to 5 to 10 m per year (Lawson and Brockett 1993).
